# Peninsula Golf & Country Club

## CASE STUDY

MAKING EVERY DROP COUNT

# Rainmaker.Earth System Impact

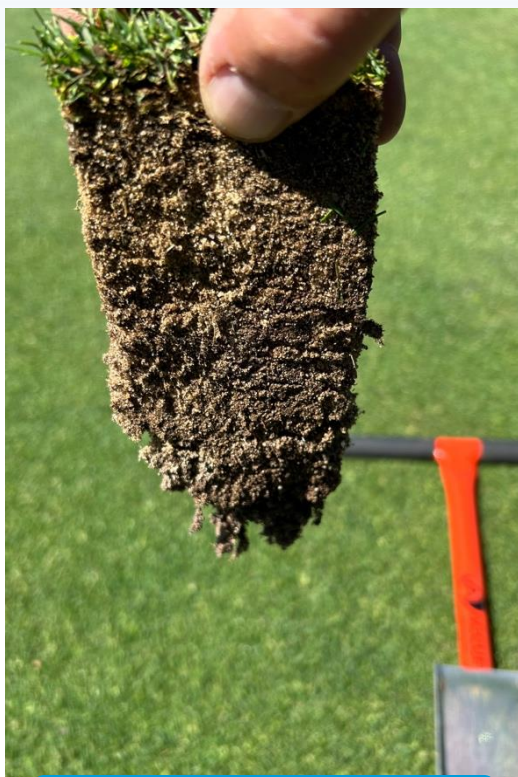
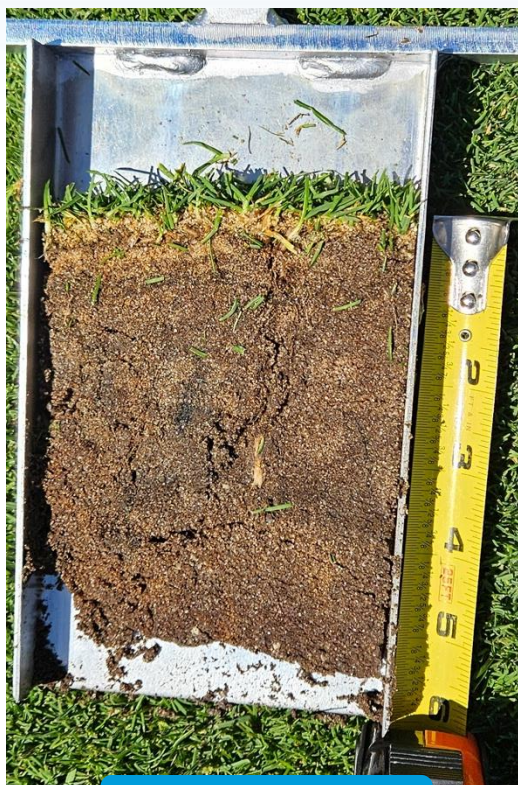
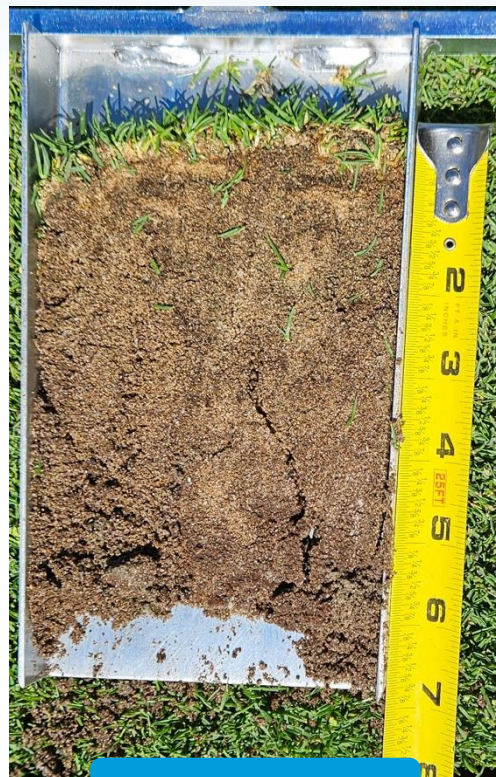
Photos show the improved rooting in Fairways, as well as healthier soil profile within 6 weeks.

Prior to Rainmaker.Earth

July 1, 2025

Aug 12, 2025

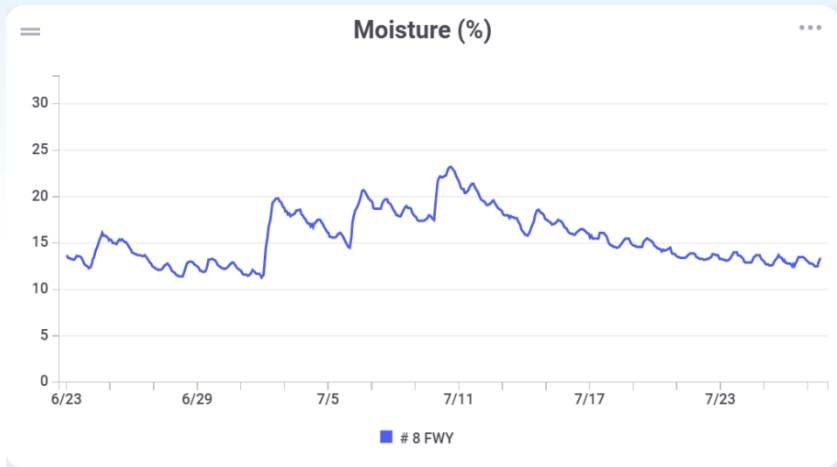
**Signs that the Rainmaker system is enhancing both soil health and water efficiency.**

## Moisture Content & Hydraulic Function

We've observed a steady increase in moisture holding capacity within the soil profile. Better water penetration from irrigation is contributing to this improvement. The extended-release curve following deep irrigation events is a strong indicator that more water is reaching deeper soil layers, offering better accessibility for root systems.

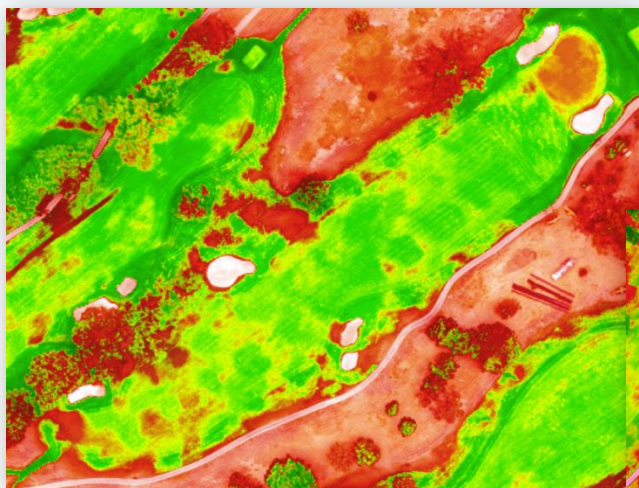
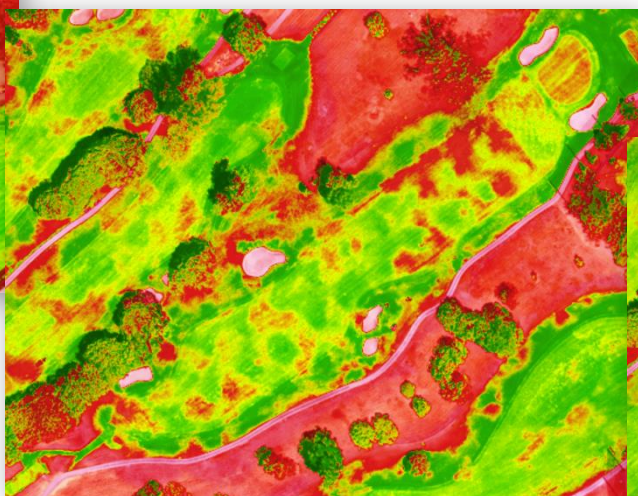
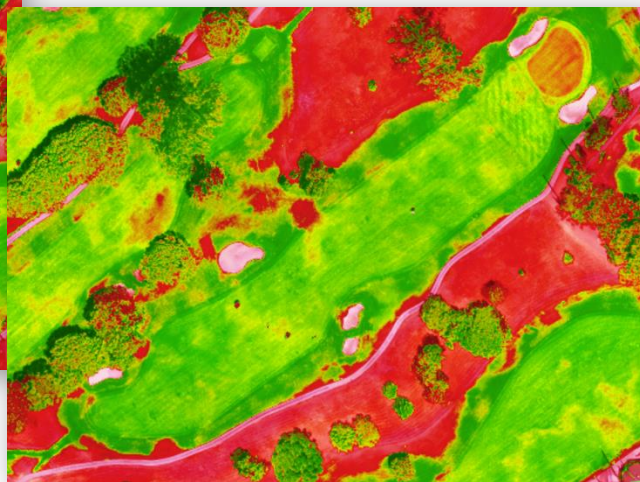
# NVDI Drone Shots

Illustrating changes in consistency of the turf

August 13, 2023

August 13, 2024

August 13, 2025

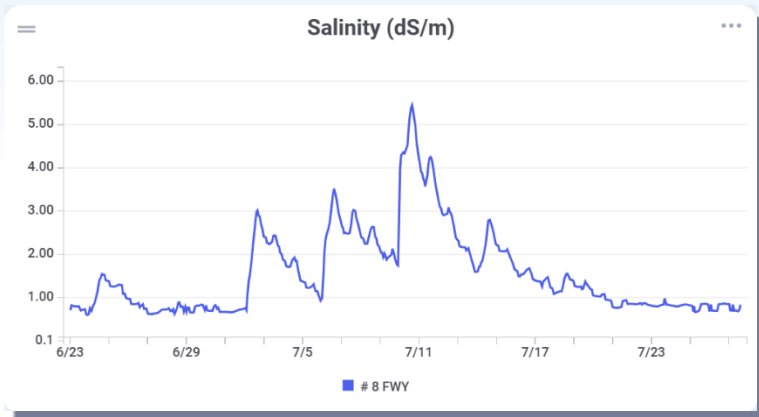
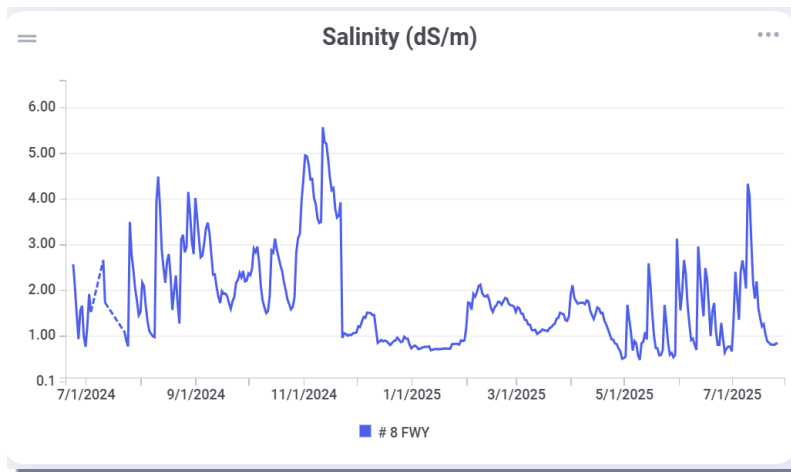
Signs that the Rainmaker.Earth System is enhancing both soil health and water efficiency.

## Salinity & Flushing Trends

Rainmaker-treated water is actively working to break down salts, as evidenced by the initial spike followed by a gradual steep decline in salinity readings. These peaks and valleys should begin to stabilize after major irrigation events as salts are broken down and precipitate through the profile. Over time, as the soil structure continues to improve, we anticipate faster salt precipitation thru the profile.
